REDGUARD®

2020 BLAST TEST SUMMARY

Blast Test Summary

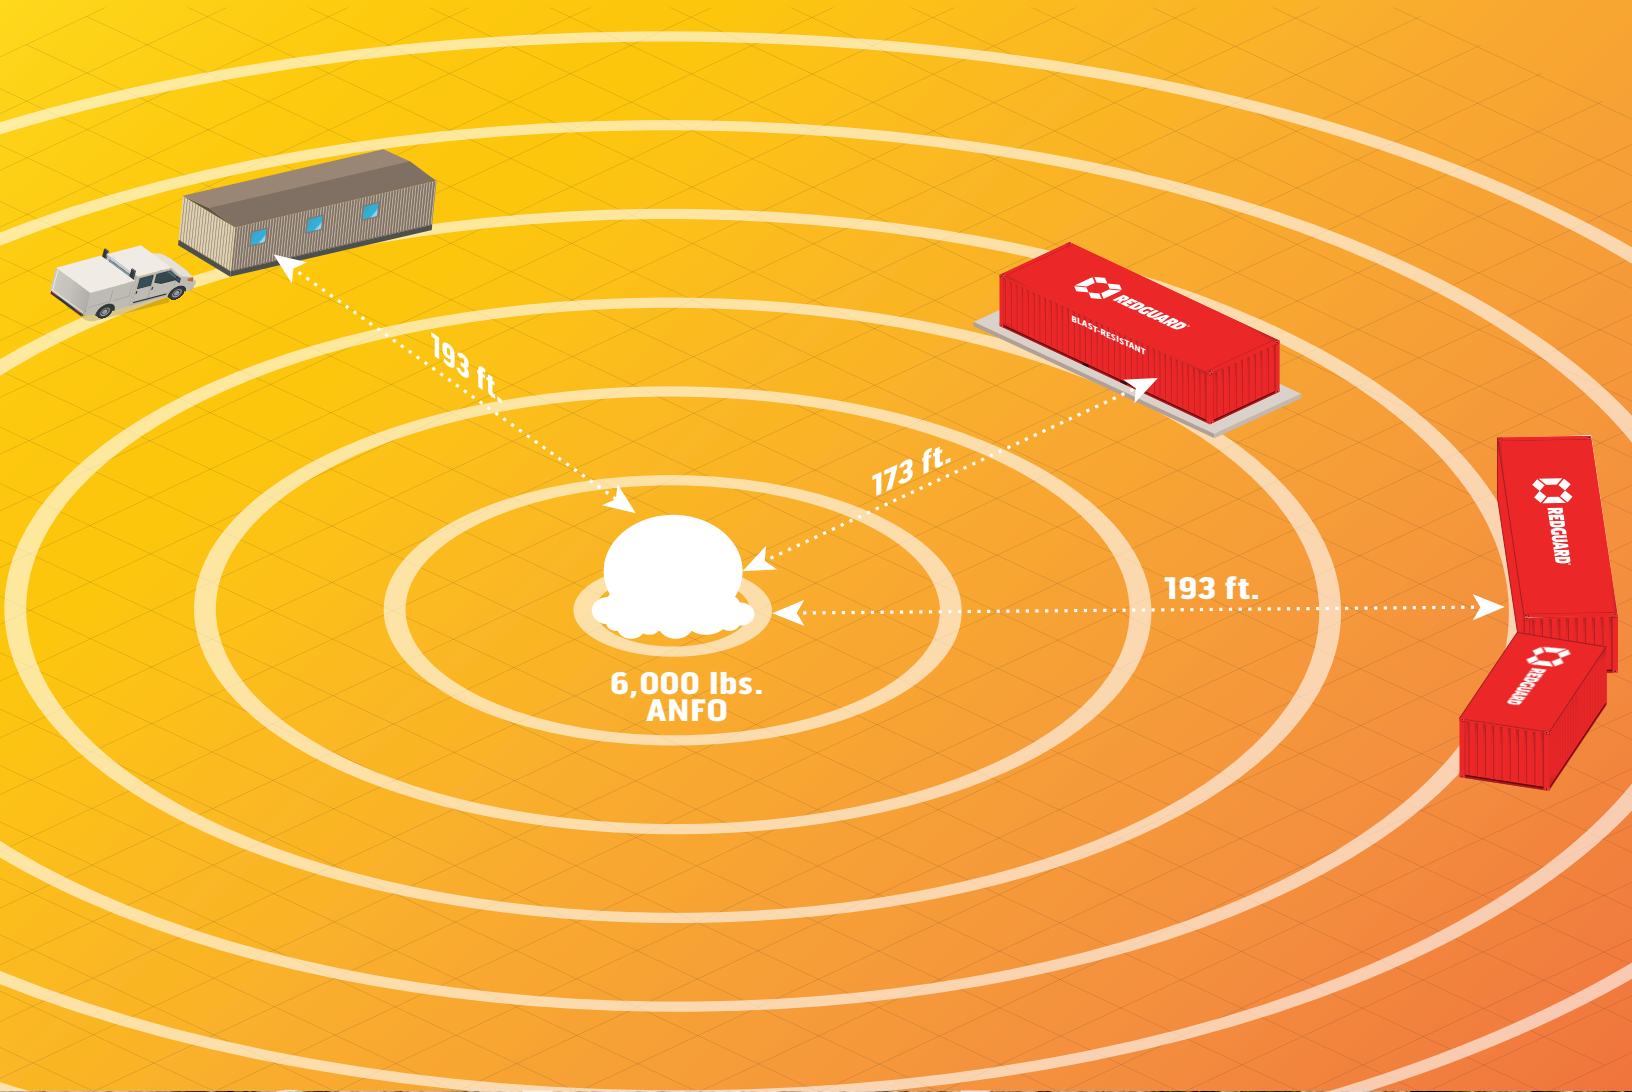
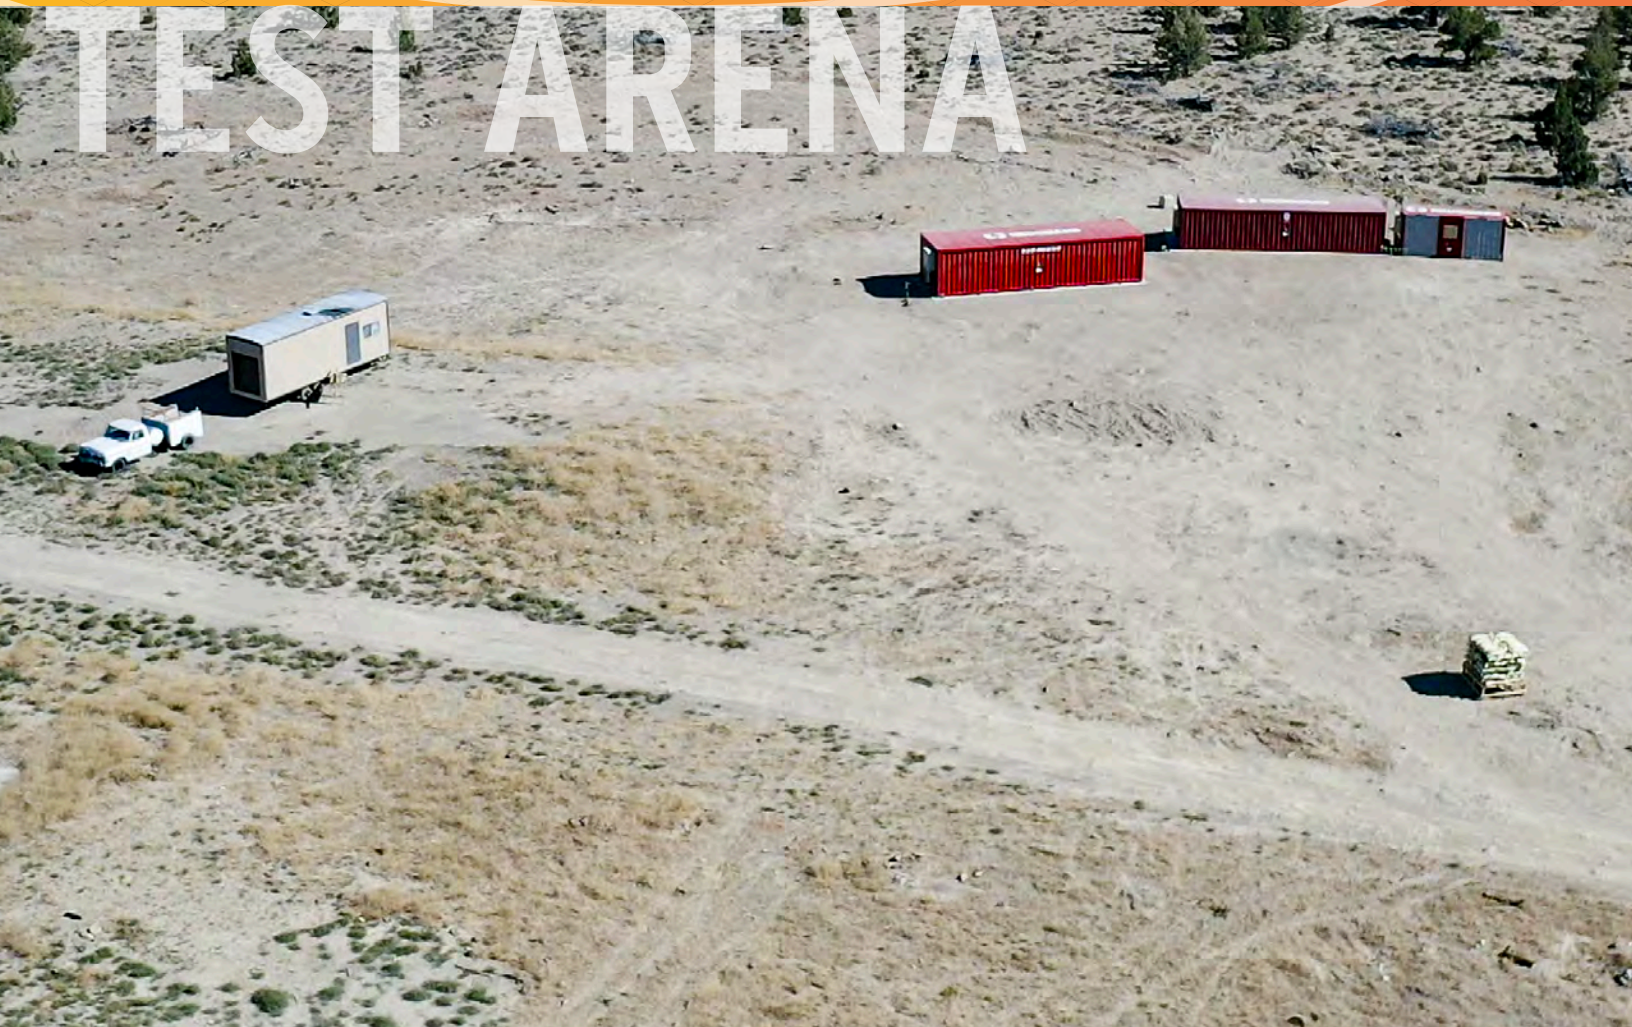
Stone-OBL Blast Testing Site

The blast testing site is located in Deschutes County, Oregon approximately 30 miles east of Bend, Oregon. The site, shown at right, is located approximately 4600 feet from the nearest utility, 6700 feet from the nearest structure, and approximately 8500 feet from the nearest public roadway. The blast testing site is accessed via a private access road.

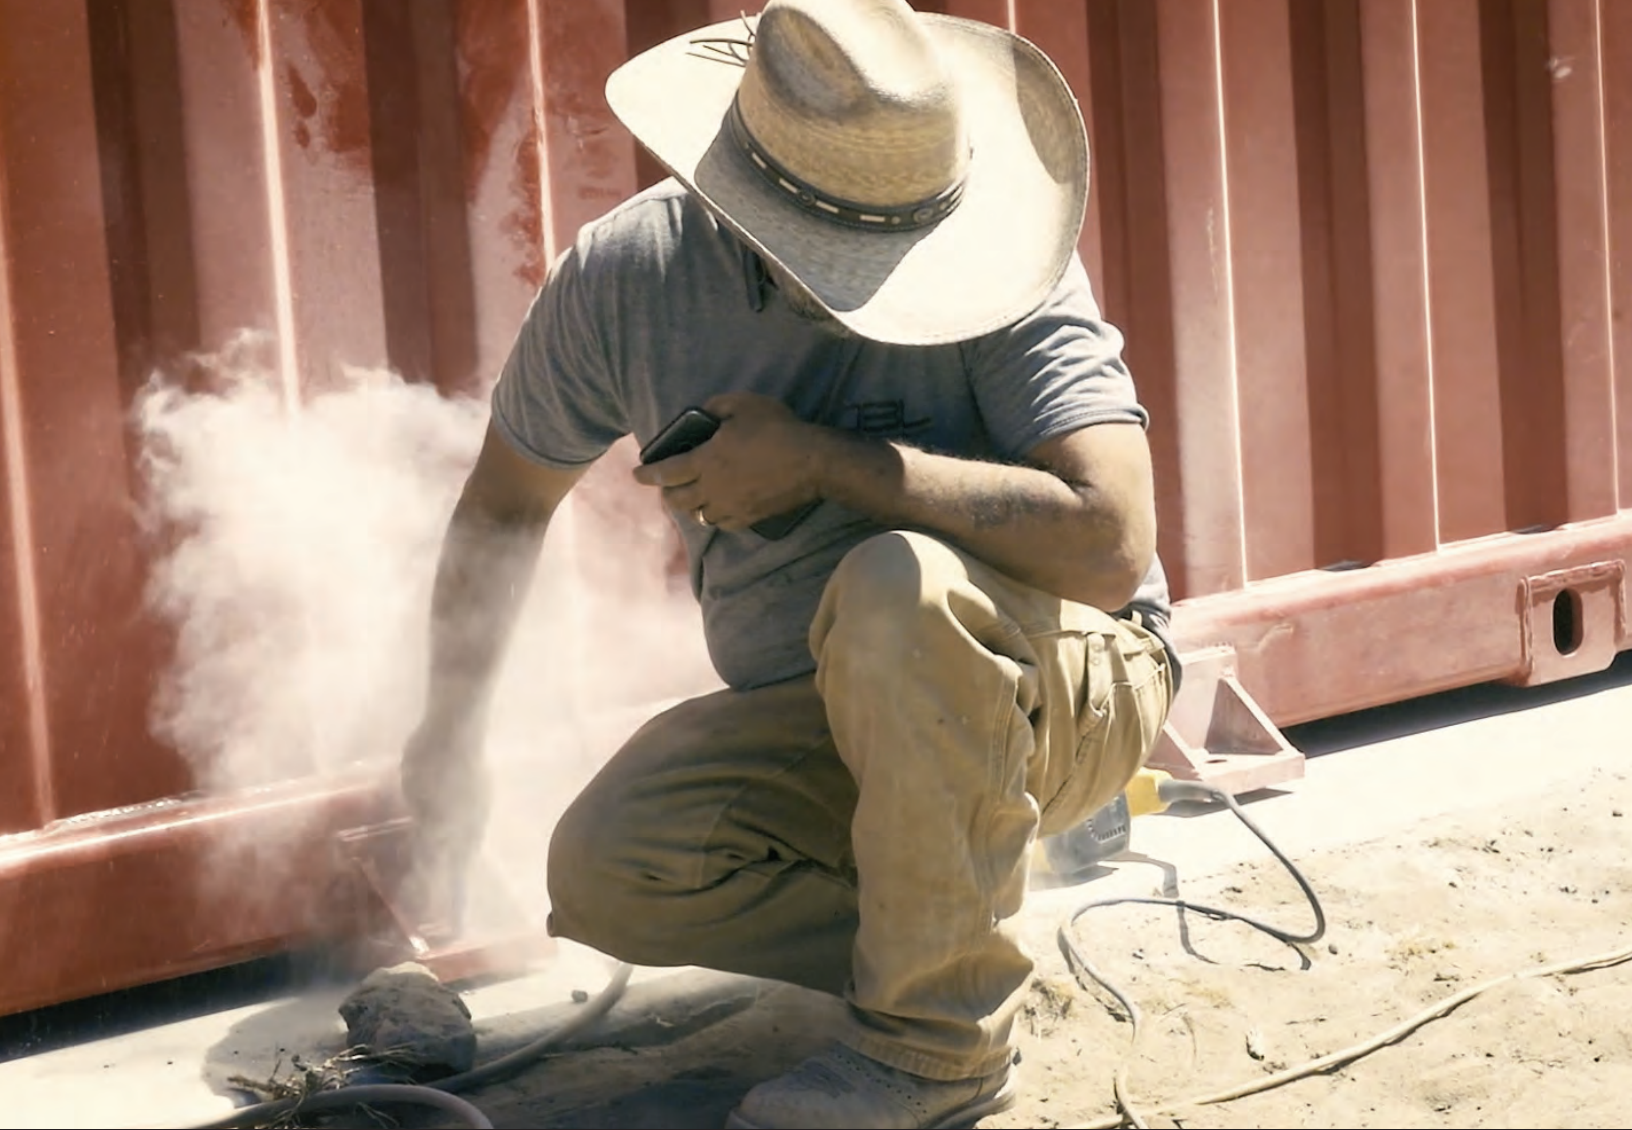
The Anchored Unit was a 12-foot by 40-foot BRB supplied by RedGuard. It was anchored to a 14-foot by 42-foot concrete pad, reinforced per RedGuard's specifications. #7 Rebar was spaced 10-inches on-center, on each face and in each direction. RedGuard supplied the 7/8-inch diameter, 13-inch long anchors used to anchor the unit to the foundation. The pad was constructed using a 15-inch thick foundation, 4,000-psi concrete, and 60-ksi rebar.

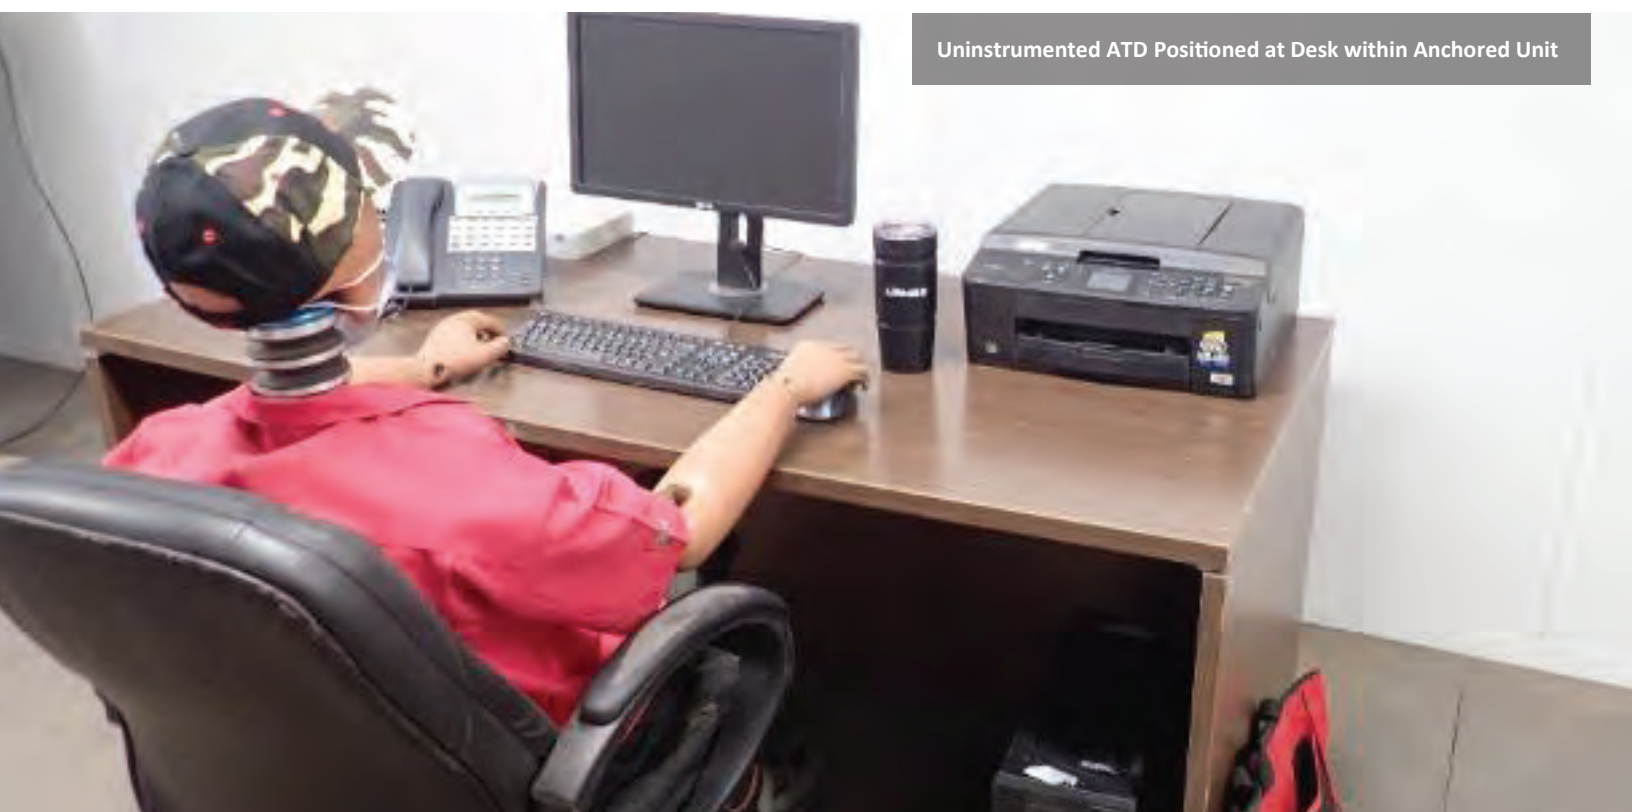
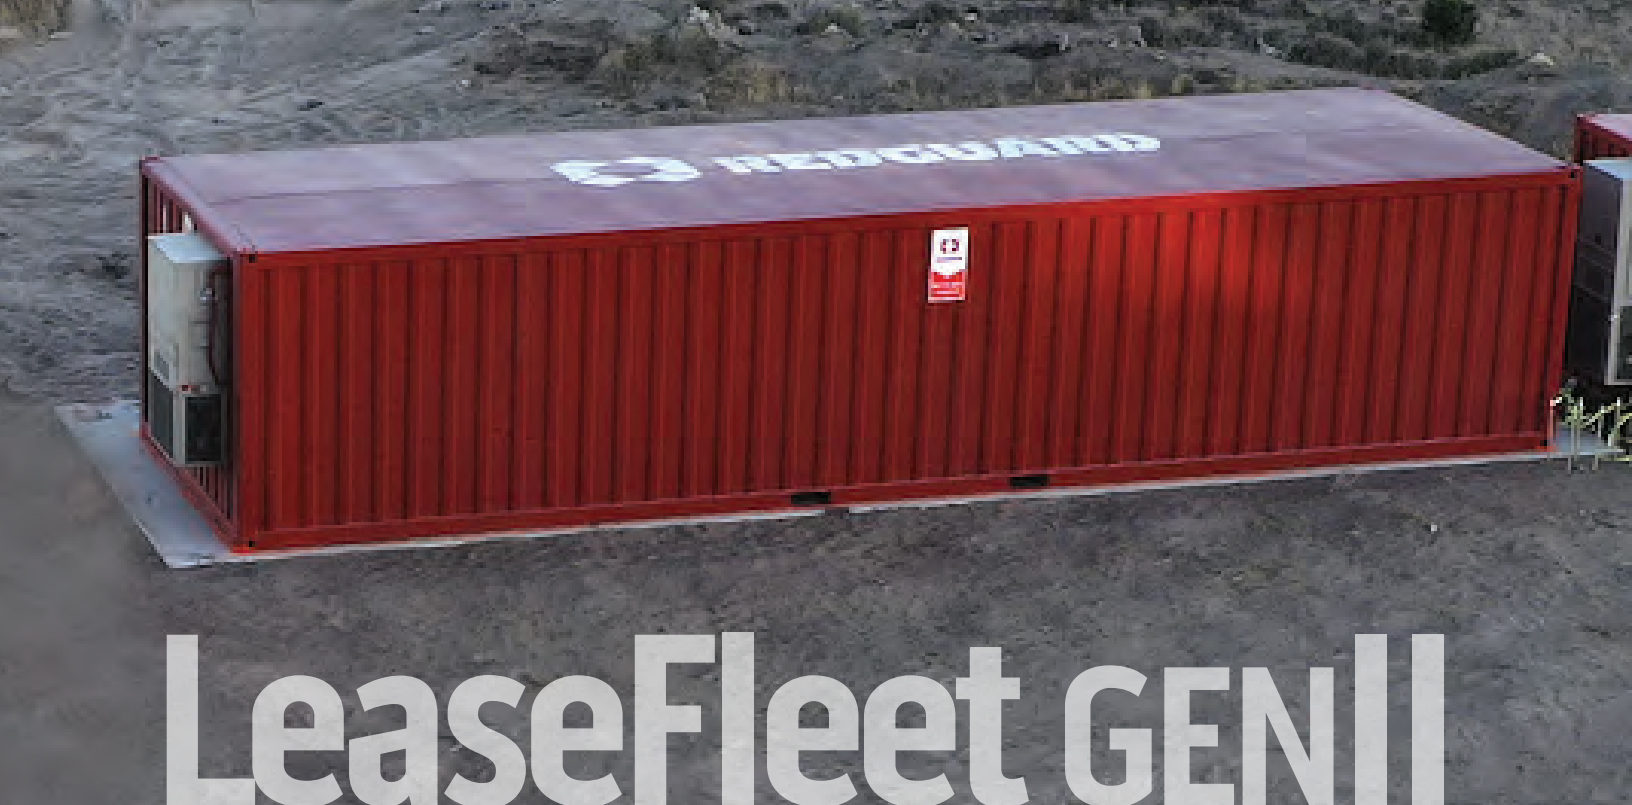
The Unanchored Unit was a 12-foot by 40-foot BRB supplied by RedGuard. It was placed on a 16-foot by 44-foot concrete pad, constructed with #5 reinforcement spaced at 12 inches on center on each face and in each direction, as shown here. The pad was constructed using a 10-inch thick foundation, 4,000-psi concrete, and 60-ksi rebar.

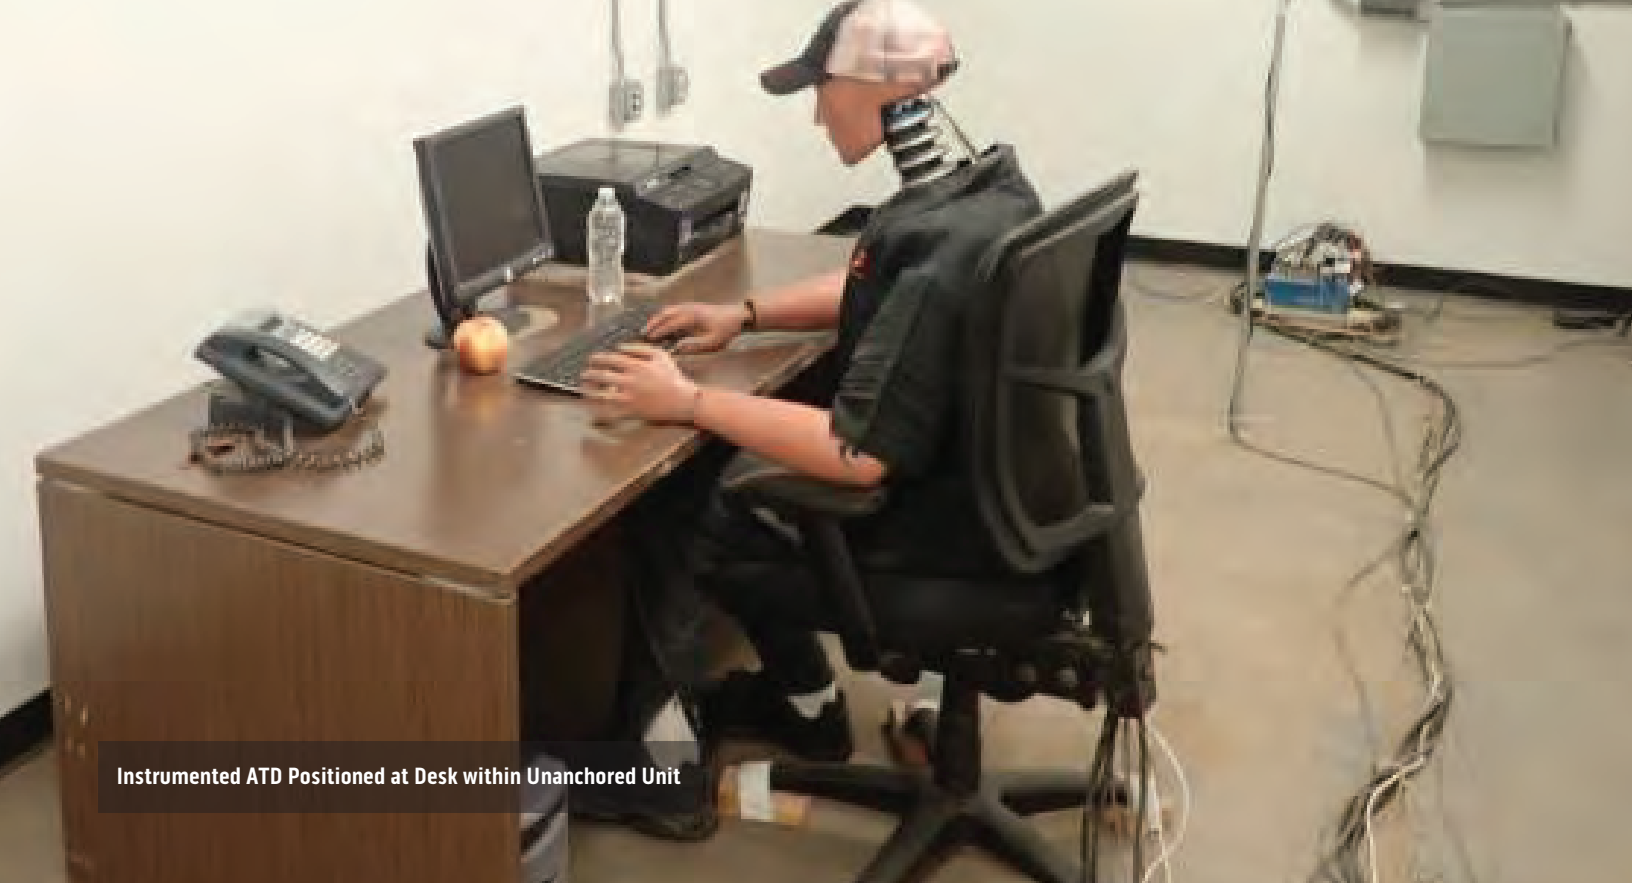
Instrumented ATD Positioned at Desk within Unanchored Unit

A desk, office chair, and mock office equipment setup was placed approximately 12 inches from the wall facing the charge. The wheels were removed from the office chair and wood blocks were taped to the chair, but the chair and desk were not secured to the floor. All office equipment placed on the desk was also unsecured to document the reaction of these items during the blast.

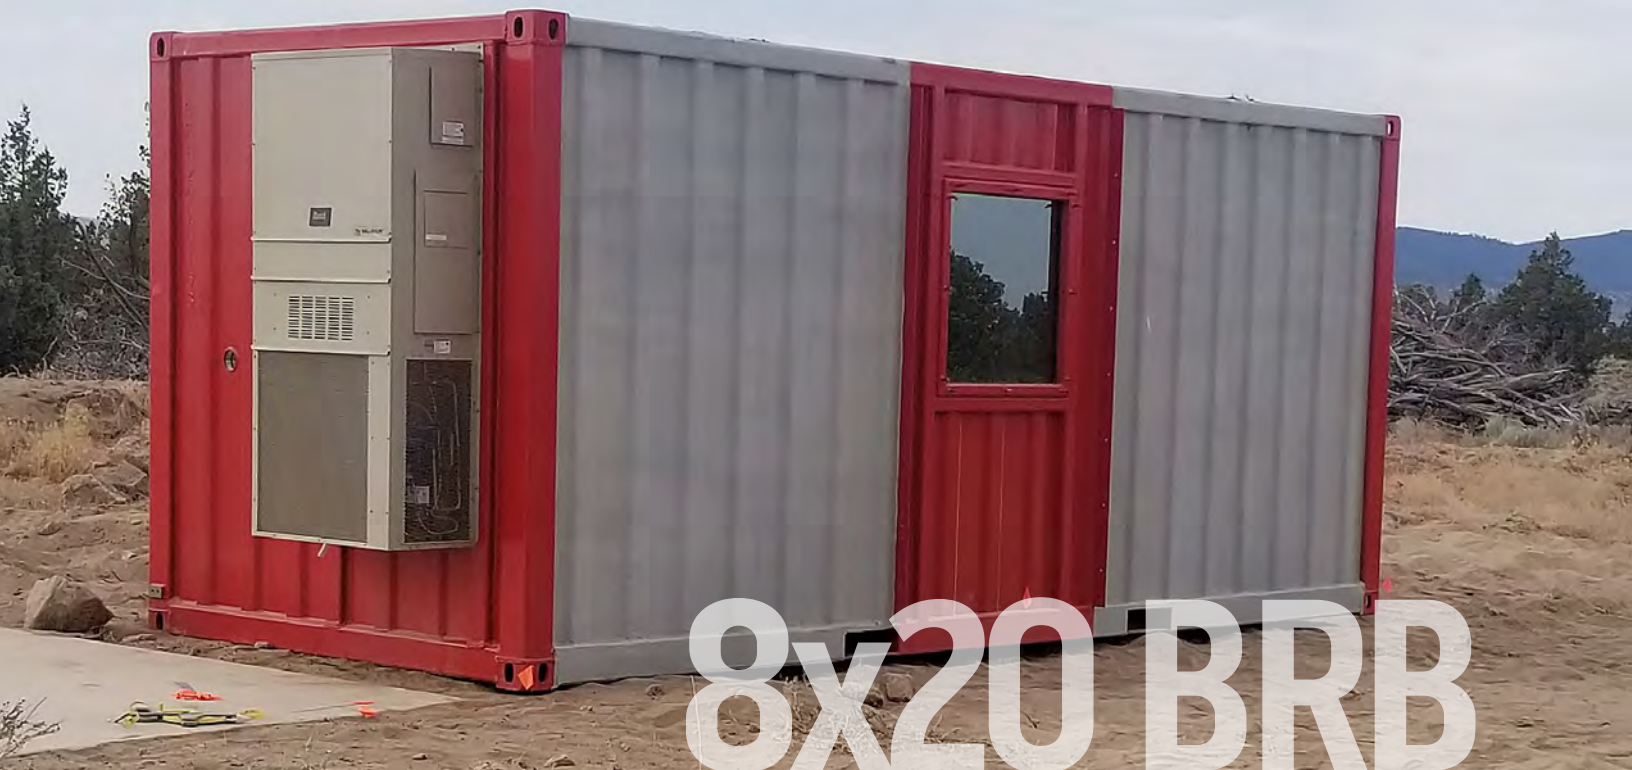
Tested for Blast and Fire

The Ground Unit was an 8-foot by 20-foot BRB supplied by RedGuard. It was placed on the ground near to the Unanchored Unit. This unit was equipped with the Passive Fire Protection coatings applied on the unit exterior surfaces prior to blast testing. The coatings were applied to the locations shown at right.

This unit was equipped with a 36-inch by 36-inch, 2-inch (nominal) thick glazing on the front face of the unit.

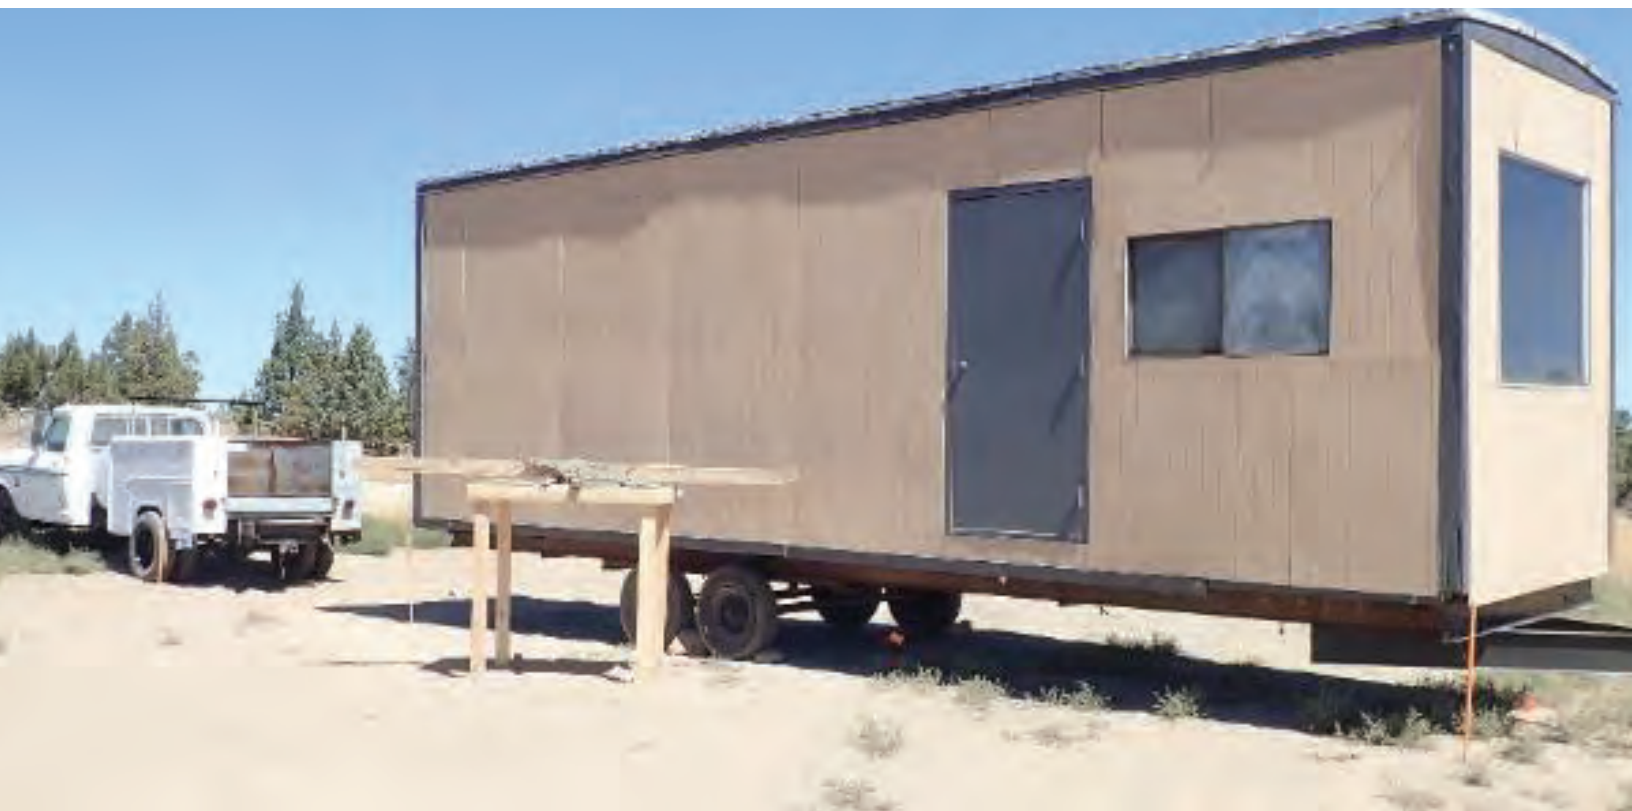
Wooden Trailer & Truck

The Truck/Trailer combination was supplied by OBL. It consisted of a truck and wooden trailer representative of standard jobsite equipment. These photos show the combination procured for this testing effort.

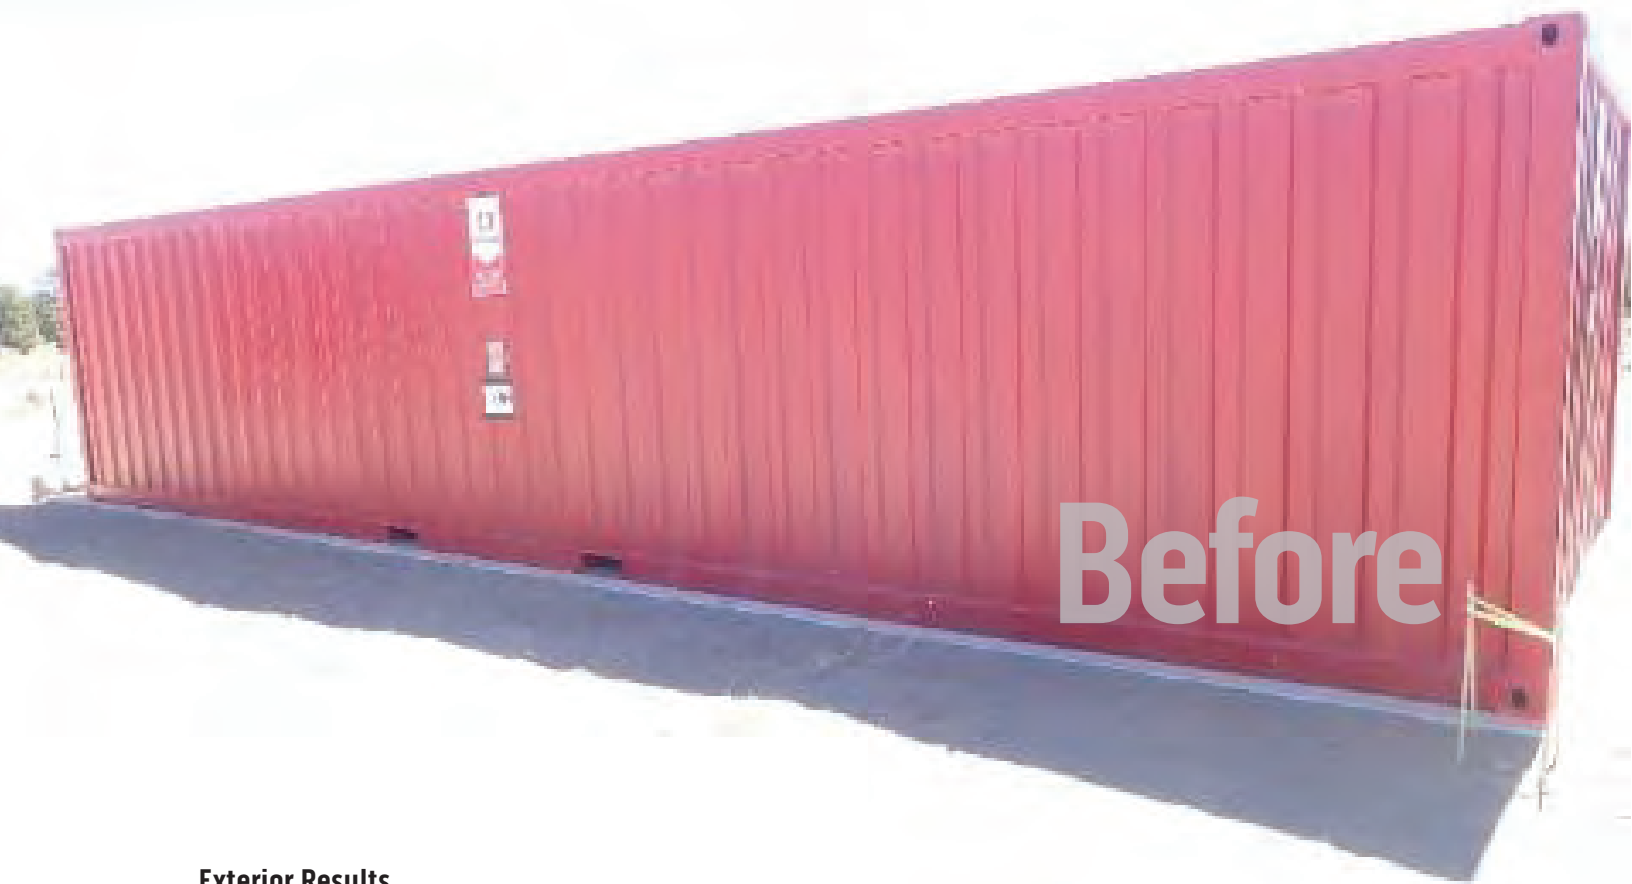
Exterior Results

There were no noticeable structural damages, nor was there notable permanent deformation of any of the exterior surfaces. These images show pre-test and post-test conditions of the Unanchored Unit.

There were no notable structural damages to the Anchored, Unanchored, or Ground Units. There were no notable permanent deformations in structural members, no noticeable cracking in welds, and the anchor plates on the Anchored Unit were wholly intact. The Unanchored Unit slid 1/4-inch toward the blast.
